PROJECT BRIEF

Abandoned Mine Subsidence Investigation – Void Detection Country Club Circle (CCC), Colorado Springs, Colorado

Project Owner: Colorado Department of Natural Resources, Division of Reclamation, Mining, and Safety (CDNR-DRMS)

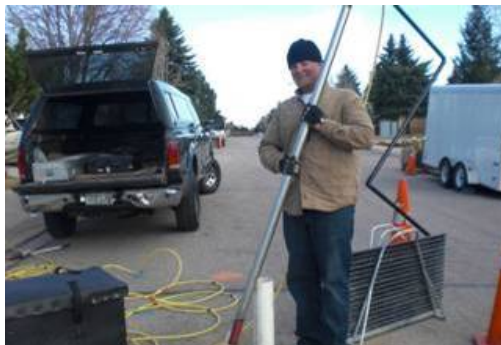
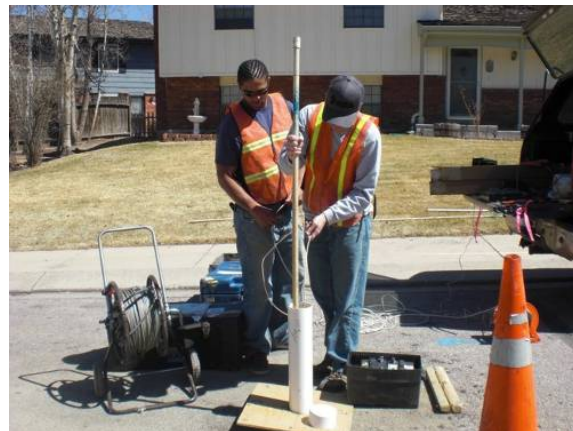
**Laser Scanning: 3D Perspective Views
of Haulageway and Cross-cuts**

Void Mapping: Conducted downhole laser and video camera surveys in real time. The laser scanning survey revealed a 10 ft wide by 7 ft high haulageway extending approximately 230 ft in the horizontal perspective. Created 2D and 3D perspective views from the data, and determined void sizes and volumes. The video camera provided records of the void conditions (such as open/collapsed areas, nature and characteristics of pillar/roof/floor), and monitored the placement of the foamed-sand backfilling of the mapped haulageway.

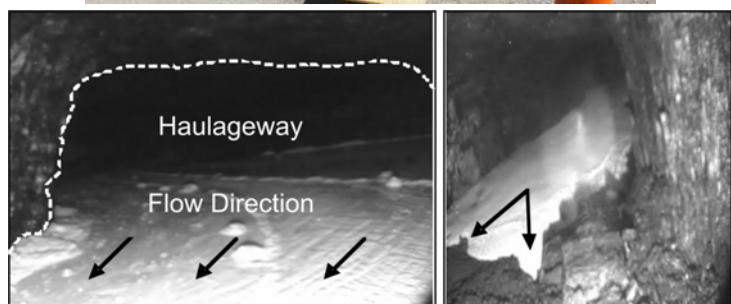
Video Image during Foamed-Sand Backfilling

Ground Stabilization: DRMS, through its contractor Hayward Baker, used foam reagents (Geofoam™ supplied by Cellular Concrete), mixed with sand, and low mobility grouting to fill and stabilize the discovered haulageway and collapsed areas. The foamed-sand mix filled the void with 267 yd³ of sand, to the approximate quantity estimated by the laser scans.
